**DEPARTMENT OF TRANSPORTATION****DIVISION OF ENGINEERING SERVICES**

Contract #: 04-0120F4Cty: SF/ALA Rte: 80 PM: 13.2/13.9File #: 69.15**SOURCE INSPECTION REPORT****Resident Engineer:** Pursell, Gary**Address:** 333 Burma Road**City:** Oakland, CA 94607**Report No:** SIR-000514**Date Inspected:** 07-Apr-2009**Project Name:** SAS Superstructure**OSM Arrival Time:** 0**Prime Contractor:** American Bridge/Fluor Enterprises, a JV**OSM Departure Time:** 12**Contractor:** Zhenhua Port Machinery Company, Ltd (ZPMC), Changxing Island **Location:** Changxing Island, Shanghai

**Other:** Surface Preparation and Coatings Application**Bridge No:** 34-0006**Component:** OBG 4BE, 4BW, Miscellaneous Metal**Bid Item:** 79**Lot No:** B226**Summary of Items Observed:**

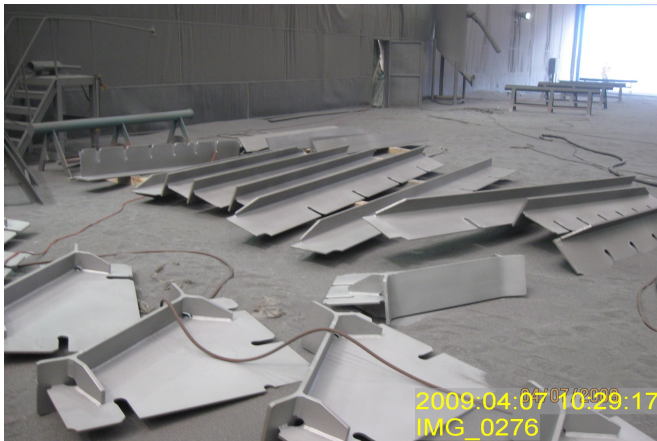
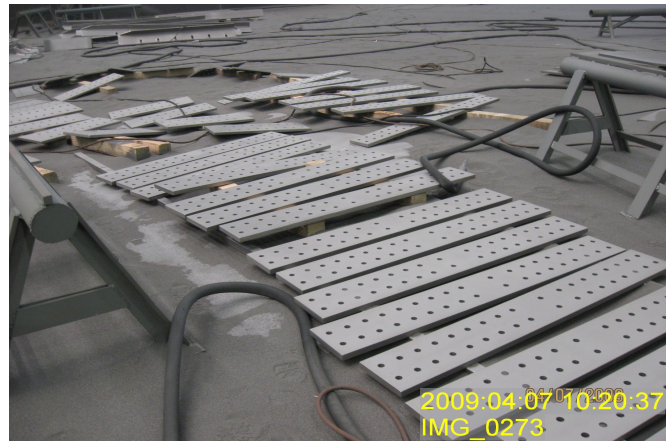
Caltrans QA Coatings Inspectors received a Notice of Inspection for to attend a joint inspection with ABF and ZPMC QC for first abrasive blast inspection on the interior ceiling and diaphragm areas of OBG 4 BW. Areas requiring grinding were identified and marked by QC and QA staff. Caltrans QA Weld Inspector's Rodney Patterson and Eric Prue performed VT inspection to locate and mark any weld repairs required. The weld repair spots were identified by placing tape over the area so it can be located after primer application. After the inspection was complete, grinding was performed. Abrasive blasting of the area was performed again. Another surface preparation inspection will be performed after blasting is complete.
